\$15M USD Saved Through Bit Trip Optimization

Confirming that worn drilling bits are the reason for low ROPs

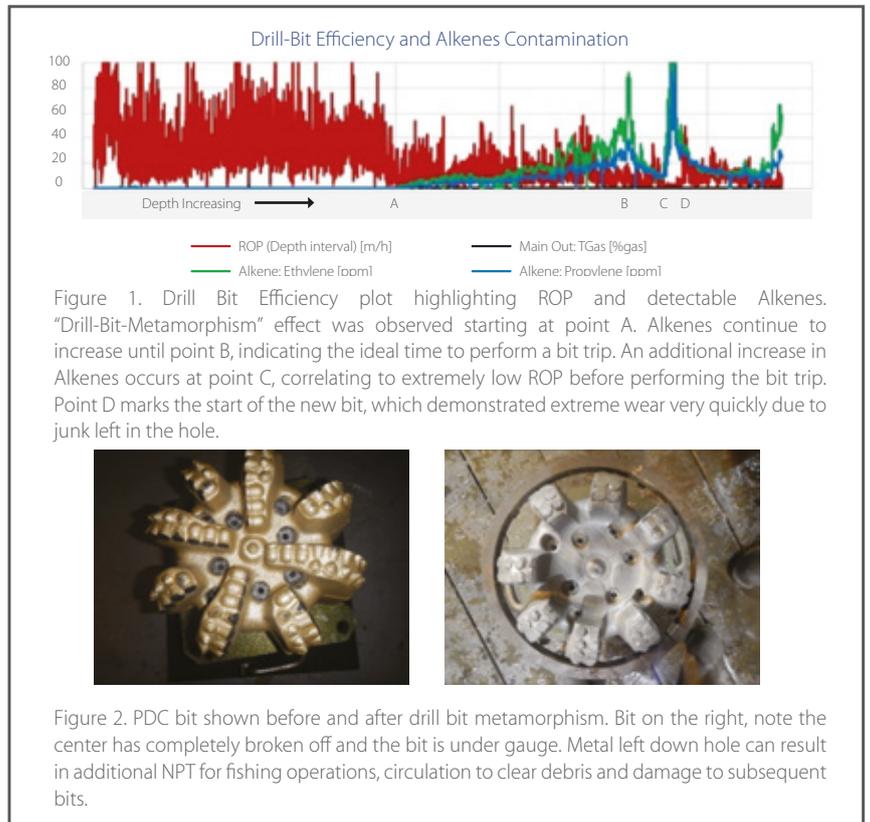
The "BitLife" service was deployed and a direct correlation was observed between the presence of alkene gas contamination (ethylene and propylene) and the low rates of penetration. The bit was removed after this correlation was seen for a period of time and the bit was found to be extremely worn and damaged. Thus, it confirmed the interpretation of the "BitLife" service. Subsequent bit runs were then performed utilizing the results from the "BitLife" service as the key indicator as to when a bit trip was necessary.

Figure 2. PDC bit shown before and after drill bit metamorphism. Bit on the right, note the center has completely broken off and the bit is under gauge. Metal left down hole can result in additional NPT for fishing operations, circulation to clear debris and damage to subsequent bits.
